Buildings Collapse and Socio-Economic Development of People in the Federal Capital Territory, Abuja, Nigeria

Hassan, I. O.
Abeku, D. M.
Salihu, C.
Maxwell, S. S.

This study examined buildings collapse and its effects on the socio-economic development of people in the Federal Capital Territory, Abuja. A collapsed building at house number 54 on Oba Overanwen Road in Gwarimpa Housing Estate was used as a case in point to ascertain the remote causes of its collapse. Factors, such as failure in foundation, the use of poor and substandard building materials, cement adulteration and seepage of ground water into foundations were investigated. The study adopted the expository and experimental approaches. Findings showed that the bearing capacity of the underlying soil in Gwarimpa collapsed site is 17.5% below the load intensity exerted on it. Concrete specimens obtained from the site and tested gave very poor results which did not meet minimum required strength of concrete of 1:2:4 or 1:3:6, respectively. Steel reinforcement bars tested also showed inadequate characteristic strength (f_y) well below 410N/mm². This study discovered among others that most of the high rise buildings do not h

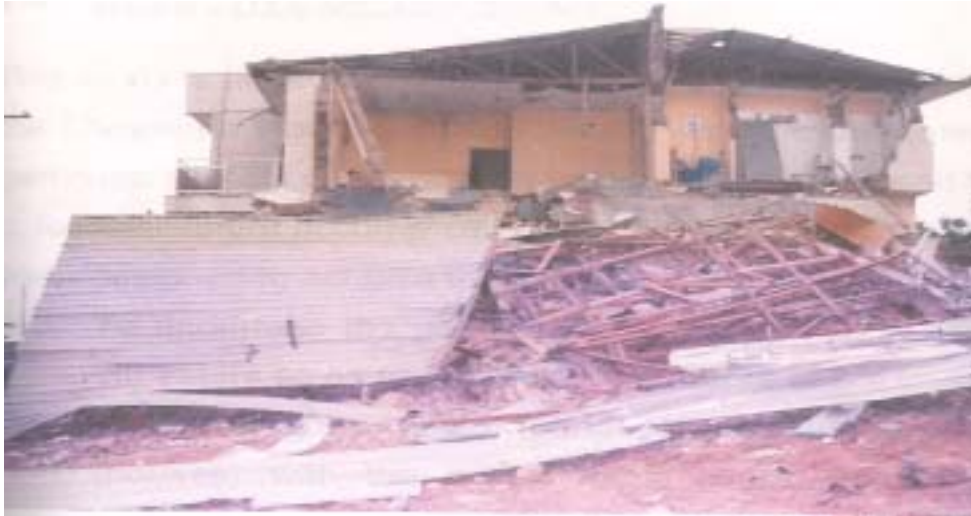
Figure 1: Collapsed House No. 54 at Oba Overanwen Road, Gwarimpa, Abuja

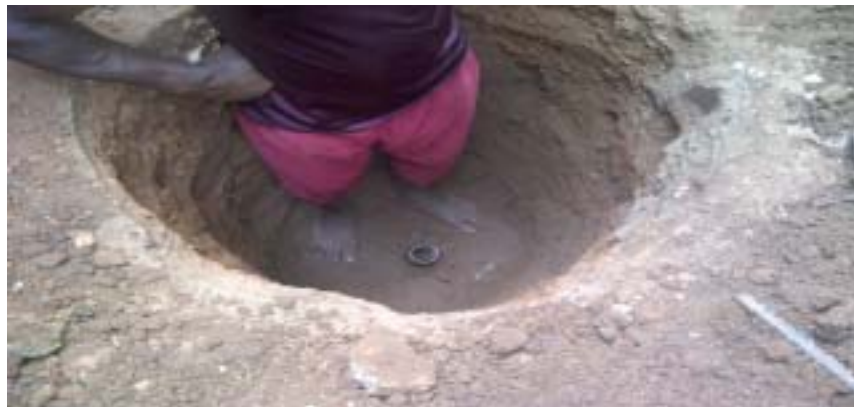
Figure 2: Trial pit with soil core cutter *Source:* Fieldwork, 2015

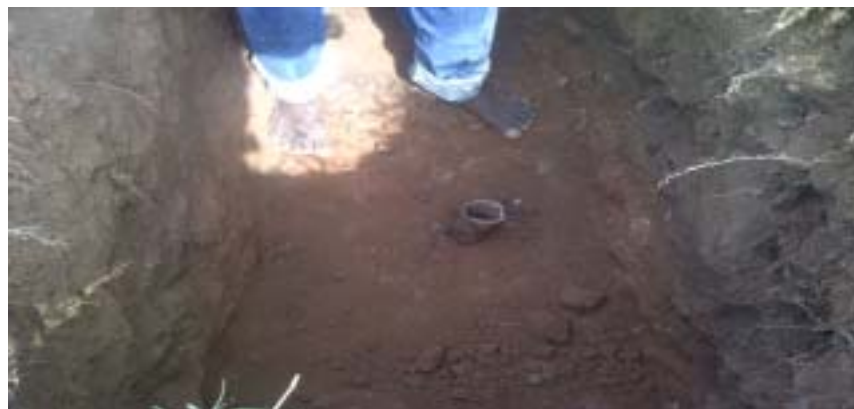
Figure 3: trial pit with core cutter *Source:* Fieldwork, 2015

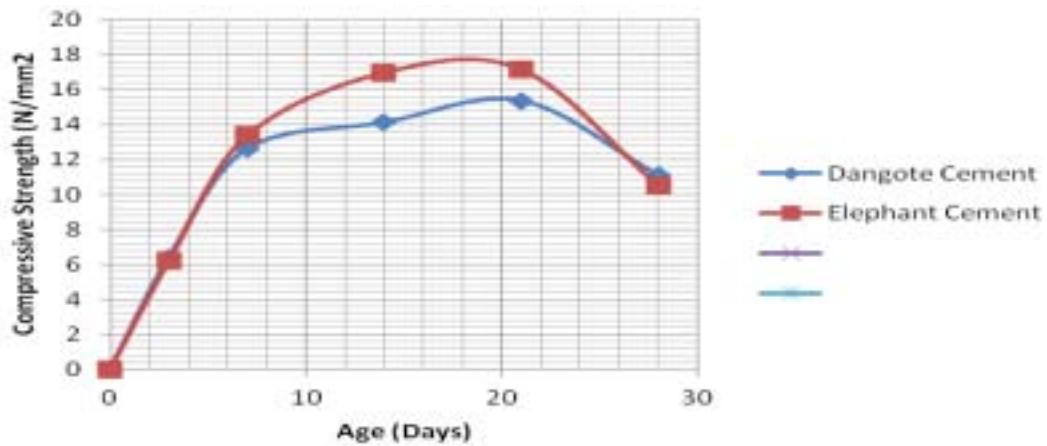
strength requirements for Portland/hydraulic cements used in concreting (Figure 1). From the result, it shows that the problem lies with the mix ratio used to produce concrete elements on the site using the cement rather than with the strength of the cement brands themselves. It should be noted that most of the collapsed buildings recorded occurred during the rainy seasons. This means that when there is a lot of intake of ground water into the subsoil particularly between construction interface and the ground, it usually weakens the subsoil beneath foundations thereby causing it to lose its shear strength/bearing ability. Investigation shows that most of the two storey buildings constructed in Gwarimpa housing estate are without provision for storm/surface water collection or channeling. Loads transmitted to the subsoil from the structure becomes too much for the subsoil when it is already weakened due to excessive moisture intake to carry, thereby causing failure. A beautifully constructed house may not last long due to lack of drainage provision for storm water collection and channeling.

Figure 4: Variation in compressive strength of cement with age

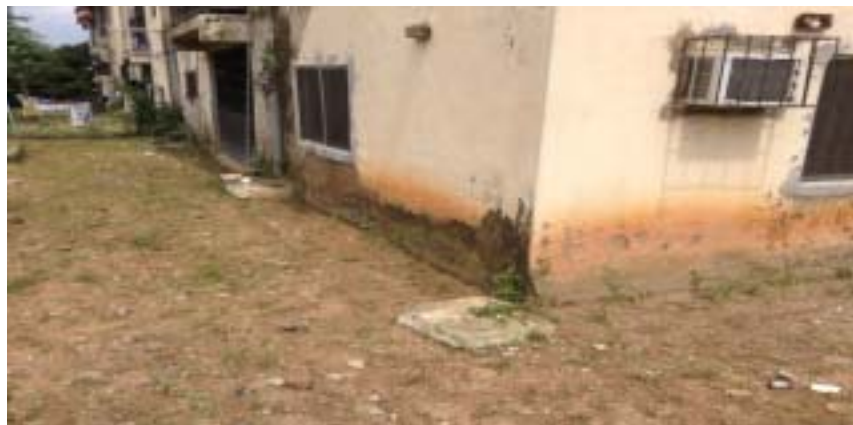
If drainages are provided as buildings are constructed, a lot of excess water will be transported away from the buildings, leaving the buildings surroundings dry and the subsoil well drained, hence, no loss of shear strength or bearing ability of the soil; and it will also reduce differential settlement. Investigation further revealed that virtually all the high rise buildings within Gwarimpa have no provision for collection/channeling of storm water away from the buildings. It has been established that nearly all collapses occurred during the rainy season (Ede 2010). The building structures stand on shallow foundations which carry heavy loads and sit on underlying soils which have low bearing capacities. The excess moisture in the subsoil causes dampness of the walls in the buildings which also leads to spalling of plaster and concrete. In this study, it is also discovered that most of the high rise buildings do not have provision for collection and channeling of storm water away from the buildings, thereby causing weakness to the underlying soil in foundations due to excess water intake during the rainy season.

Figure 5: No drainage provision in Gwarimpa *Source:* Fieldwork, 2015

There is the need for the collection and channeling of storm water either through the construction of drainages/gutters around high rise buildings or the provision of septic tanks or any other method of channeling excess water away from the surroundings of the buildings in order to keep the foundations safe from being over saturated with water which leads to shear failure. Government must, through the standard organization, ensure availability of only good quality materials for the construction market. Cost reduction measures need to be employed to reduce the cost of construction. Dealers in poor quality construction materials should desist from such act. There is need for materials testing laboratories. This intervention will provide easy access to testing facilities so that there is no excuse for not supervising any project comprehensively. Government must demonstrate adequate interest in project safety by prosecuting, with all seriousness, offenders whose activities result in the collapse of structures.

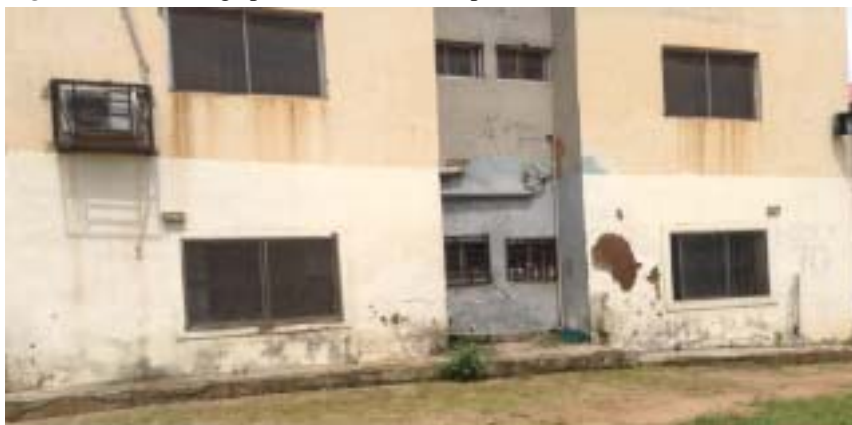
Figure 6: High rise building without drainage in Gwarimpa. *Source:* Fieldwork, 2015
