Sub-soil Water and Structural Foundation Study in Ilaje Community School and United Grammar School, Irele, Ondo State, Nigeria

Base Map of The Study Areas: Ilaje and Irele Community

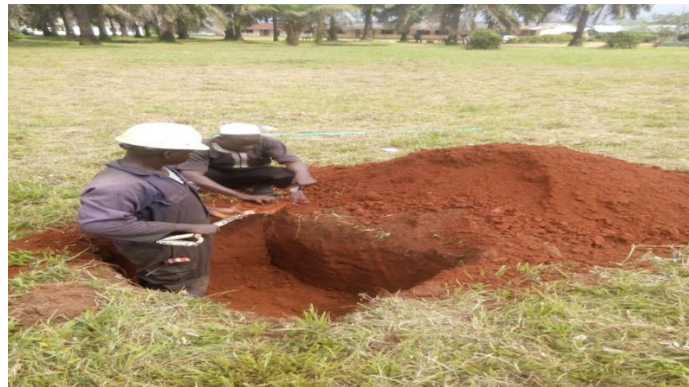
Plate 1a: Photograph of trial pit showing the collection of Samples from the study areas of Irele of disturbed samples of 1.0-2.5

Two trial pits were excavated (each at the centre of the study area) to obtain soil samples as possible as core materials. The samples were collected into plastic samples for disturbed samples labeled as IHSI and undisturbed samples. The samples were blown at 2.0m so we could obtain any samples for U4bag and transport them to the soil laboratory. The soil was air-dried and lightly crushed into smaller pieces for classification, strength, and specialized tests (according to the British Standard (BS 1377:1990)). Disturbed samples were labeled as UGS 0.5m, UGS 1.0, UGS 1.5, UGS 2.0, UGS 2.5m, and Undisturbed samples were labeled as UGS 1.0m U4, UGS 1.5m U4, UGS 2.0m U4, UGS 2.5m U4, and it does not occur in other locations at the Ilaje community.

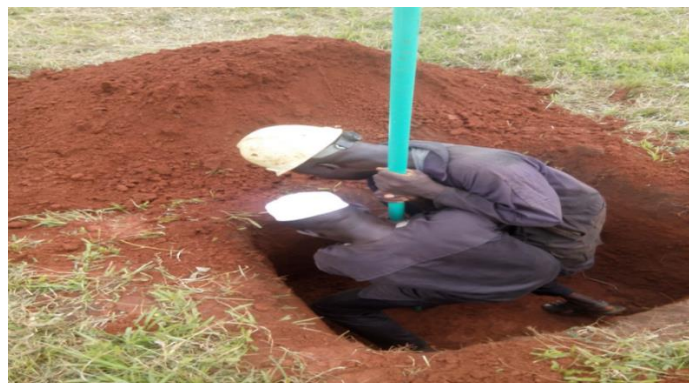
Plate 1b: Photograph showing the collections of undisturbed samples of 1.0m - 1.5m layer (Samples collection from the study areas of Irele)

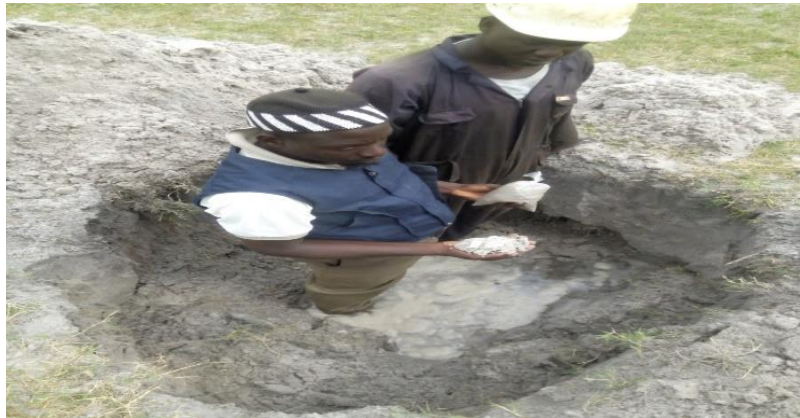
Plate 2a: Photograph of trial pit showing the collection disturbed samples of 0.5m- 2.5m Ilaje

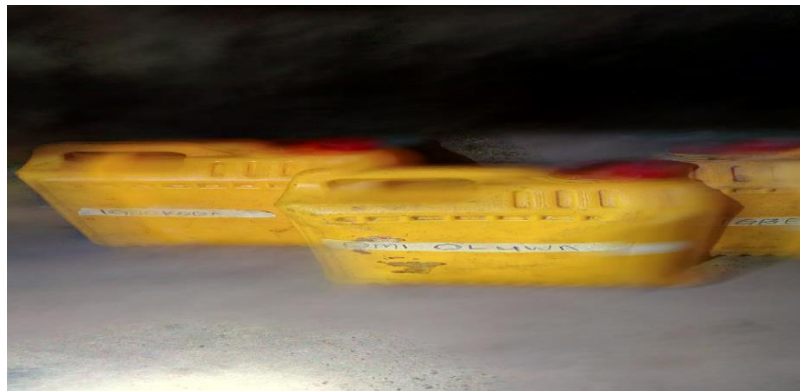
Plate 2b: Water samples from Ilaje and Irele communities

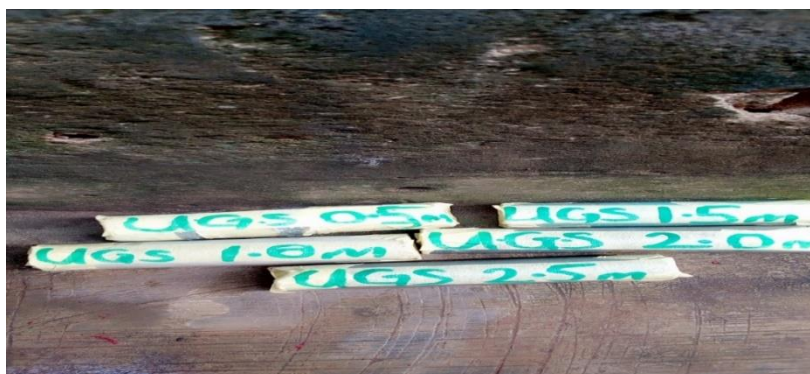
Plate 3a: Undisturbed samples from the Irele community only
