Geospatial Surveillance of the Degraded River Komadugu-Gana Area, Potiskum, Yobe State, Nigeria

Oladimeji, Bunmi
Nyanganji J. K.
Ikusemoran Mayomi

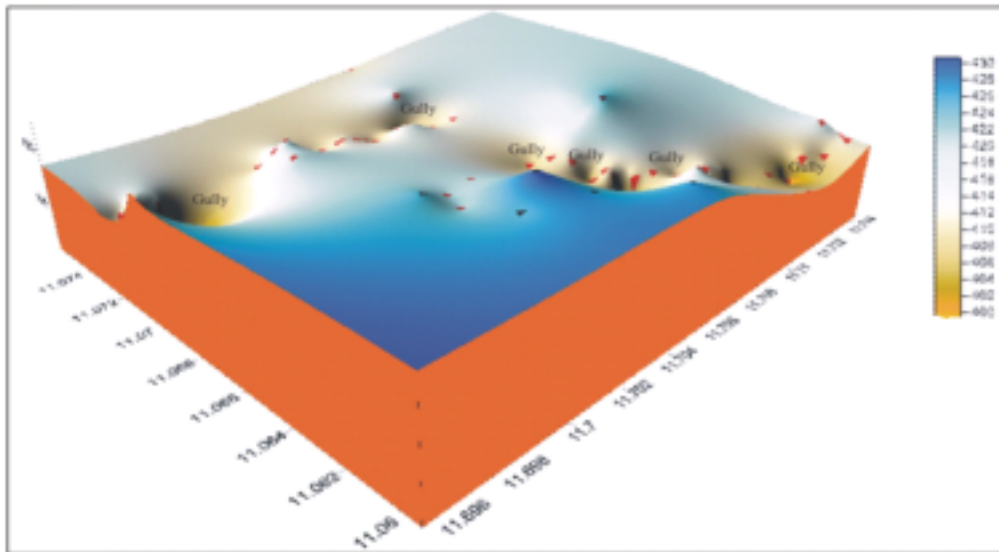
Fig. 3: 3D view of the Study Area. *Source:* Generated from points obtained from GPS (2016)

Fig. 3 shows the 3D view of the study area which conspicuously revealed the river valleys and the gullies in the valley. It also revealed the undulating nature of the eastern part of the area and the rugged western part. Gully erosion was observed to be more severe in the rugged eastern areas because topography through slope (steep or gentle) influences various types of fluvial processes. The nature of topography therefore, determines the severity of fluvial erosion in an area. In a clearer term, Oyegun, (1987) points out that the nature of topography has much impacts on soil surface flow. For instance, areas with 11 degrees of slope experience more serious soil erosion than a nearly level or plain surface, (Young, 1992; Davis, 1980).

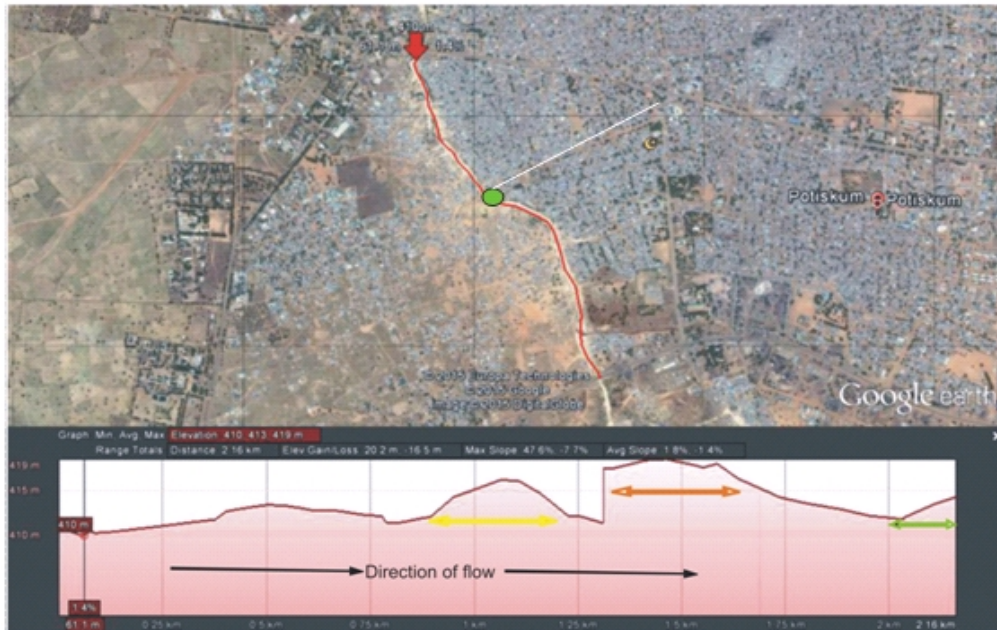
Fig. 5: Elevation Profile of River Komadugu-Gana valley in Potiskum (2005)

The elevation profiles in Figures 4 and 5 clearly demonstrated drastic changes in the river floor of Komadugu-Gana in Potiskum. For instance, the yellow, brown and green double edged arrow was used to analyze the changes in the area. The area around the yellow arrow in Fig. 4 was found to be of the highest elevation, about 416m in 2005. The brown arrow in Fig 4 shows a relatively undulating land area immediately after the yellow arrow area. This undulating land area was however found to have developed into an area of highest elevation of more than 419m in 2014 which might have resulted from the accumulation of the eroded materials from the river upstream. This means that at least, 3m of eroded particles have been accumulated in the area within the study period. The materials were accumulated around the brown arrow area because the river has to meander through the river bends and hence, slows the water velocity which results into accumulation of materials around the river bend (Fig.4). The elevation of the river valley around the green arrow area was found to be around 416m above sea level (asl) in 2005. The elevation of the same area in 2014 was discovered to have drastically reduced to less than 415m above sea level (asl) indicating a minimum of 1m erosion.

The green spot along the river valley signifies the point of the deepest part of the valley as derived from the GPS coordinates. This same point was discovered to be located where sand mining was mostly carried out. In fact, most of the sands that are used by the inhabitants were derived from the place. For this reason, a road was constructed (white lines in Figures 4 and 5) right into the bank of the river to ease the movements of the sand miners. Therefore the gully around this point was definitely aided by the sand mining. During the process of sand mining, according to Otu (2014), accelerated erosion and associated land degradation problems sets in. They concluded that the environmental effects of sand mining activities as are largely negative on riparian habitats; riverbed abilities to

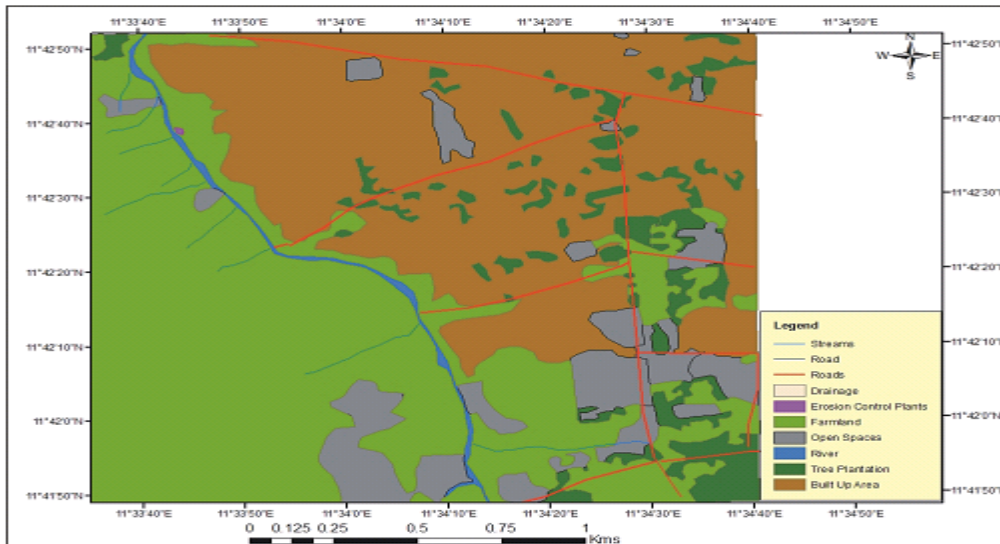
Fig. 4: Digitized Landuse and Landcover Features from 2005 Google Image

The detection of the landuse and landcover types within the study area was made possible and obtained through the acquisition of the Google Earth 2005 and 2014 images (Figs.4 and 5) respectively. Table 1 presents the information of the results of the calculated area of the landuse and landcover types in 2005 and 2014. The landuse of the area mostly comprises of built-up areas, tree plantation basically of Neem trees, orchards of fruit trees such as cashew, mangoes as well as guava plants. Soil erosion control features which include embankments and erosion control plants were mapped. Other identified features include: open spaces, farmlands and the river valley. The area coverage of each of the classes as calculated is presented in table 2

In 2005 as revealed by table 2, the entire study area was mainly comprised of built-up and farmland areas. These two landuse classes collectively accounted for about 80% of the area. There was also no embankment for drainage control in the year. However, in 2014, though the two landuse features still cover the largest part, but farmland was no longer the largest area as built-up areas became the largest landuse in the area. The built up areas have even expanded across to the western rugged areas. This increase in the land area for residential purposes resulted negatively on other landuse and landcover classes. For instance, it led to decrease in the land area of open spaces, tree plantation and farmlands. The width of the river valley in 2014 was also discovered to have increased more than double its original width in 2005 which indicates soil erosion in the river valley areas. Consequently, resulting into gully erosion as observed by Ologe (1972) that fluvial erosion create sheet, rill and gully erosions, which are already observable in the field in many parts of the savanna. Hence, gullies develop where run-off is concentrated along definite channels on the slope and grow lengthwise by headward erosion (or head scarp retreat) and sideways by basal sapping, (Coates, 1978; Igbokwe, 2008; Ologe, 1972, Nyanganji, 2009).
